**Flood Control Project Maintenance  
Levee Inspections****LMA District Cover Sheet****Spring 2012 Levee Inspection Results****Reclamation District No. 0404 Boggs**

**Levee Inspection Report By Mile - Spring 2012**

**Reclamation District No. 0404 Boggs**

Waterway				Bank	Unit Miles	Inspection Start/End	Inspector	
Unit No. 01 San Joaquin River				Right	2.36	03/27/2012 03/27/2012	Richard Willoughby

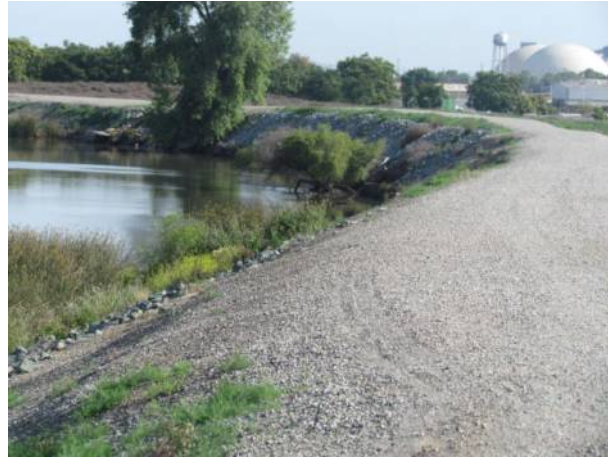
Levee Mile Report Line	4
Start Levee Mile	0.00
End Levee Mile	2.35
Location	Land Side
Category	Earthen Levee
Item	Vegetation

Looking north at typical view of levee waterside.

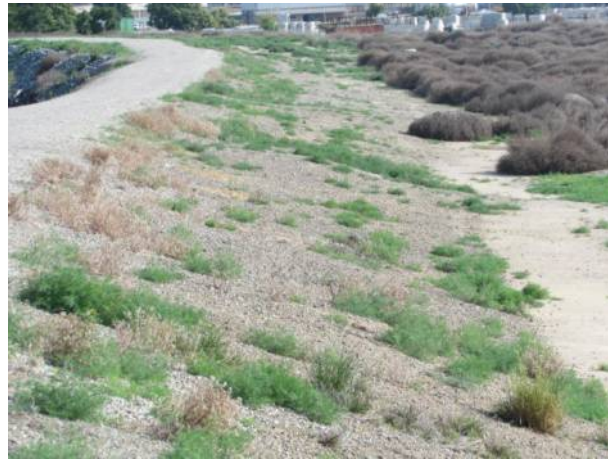
Levee Mile Report Line	5
Start Levee Mile	0.00
End Levee Mile	2.35
Location	Water Side
Category	Earthen Levee
Item	Vegetation

Looking north at typical view of levee landside.

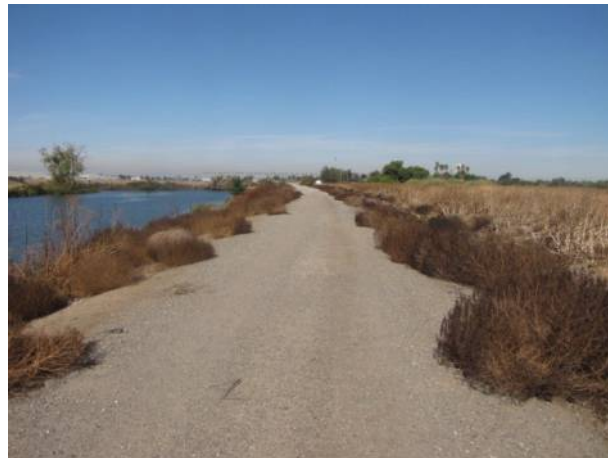
Levee Mile Report Line	6
Start Levee Mile	0.03
End Levee Mile	0.48
Location	Land Side
Category	Earthen Levee
Item	Vegetation

Looking north at modest vegetation on landside and waterside slopes.

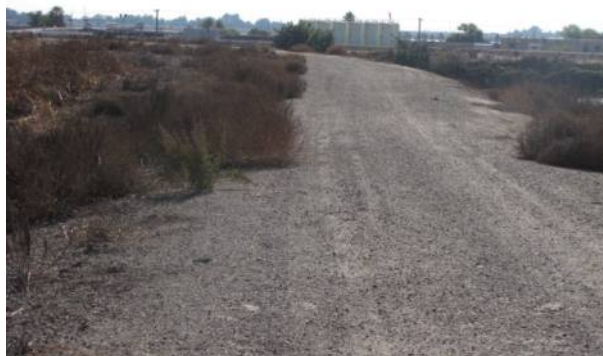
Levee Mile Report Line	7
Start Levee Mile	0.03
End Levee Mile	0.20
Location	Water Side
Category	Earthen Levee
Item	Vegetation

Looking south modest vegetation on waterside slope.

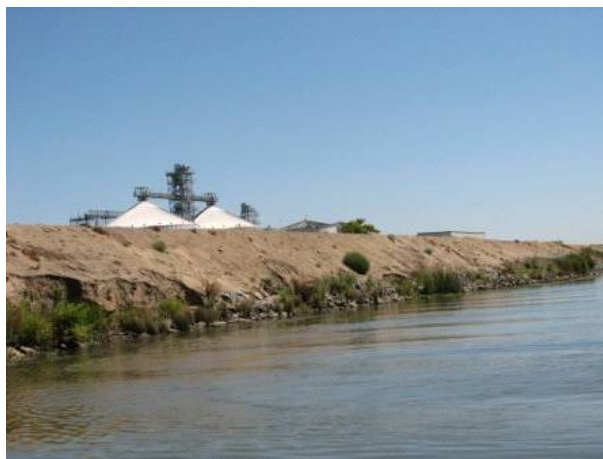
Levee Mile Report Line	8
Start Levee Mile	0.21
End Levee Mile	0.25
Location	Water Side
Category	Supplemental
Item	DWR Erosion Survey

Upstream view of Site. Progressing pocket erosion visible.

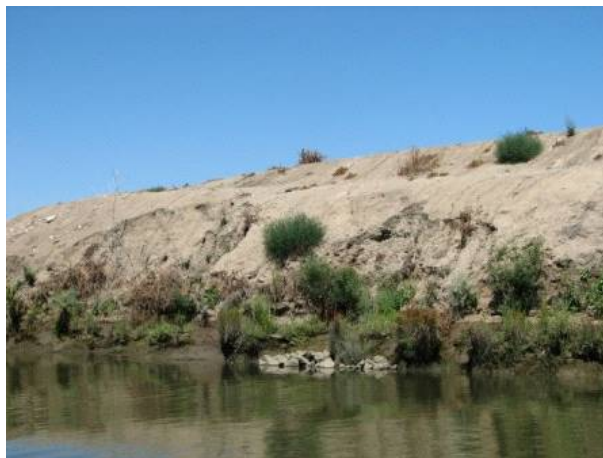
Levee Mile Report Line	8
Start Levee Mile	0.21
End Levee Mile	0.25
Location	Water Side
Category	Supplemental
Item	DWR Erosion Survey

Front view of the site

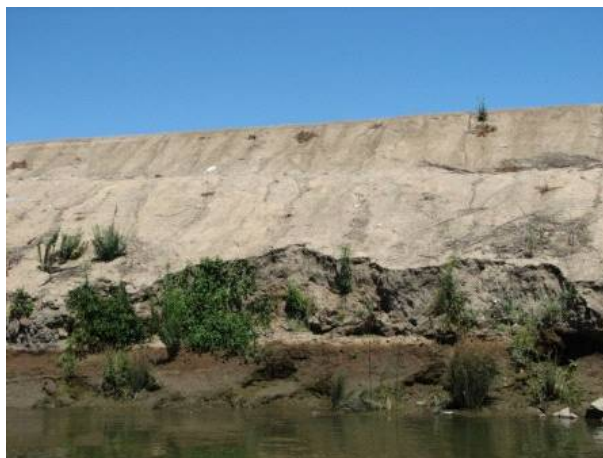
Levee Mile Report Line	8
Start Levee Mile	0.21
End Levee Mile	0.25
Location	Water Side
Category	Supplemental
Item	DWR Erosion Survey

Front view of the site

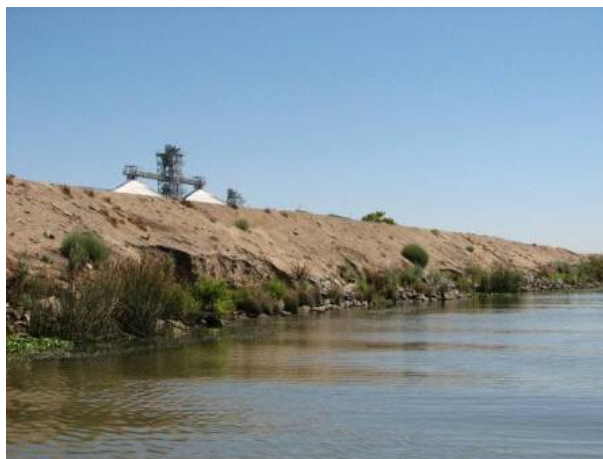
Levee Mile Report Line	8
Start Levee Mile	0.21
End Levee Mile	0.25
Location	Water Side
Category	Supplemental
Item	DWR Erosion Survey

Upstream view of the site

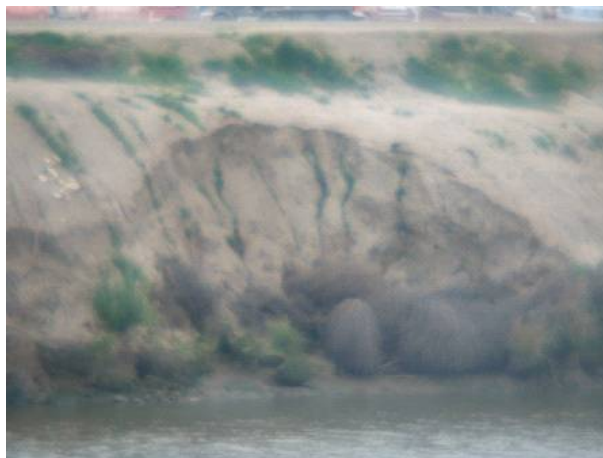
Levee Mile Report Line	9
Start Levee Mile	0.24
End Levee Mile	0.27
Location	Water Side
Category	Earthen Levee
Item	Erosion / Bank Caving

Erosion from LM 0.24 to 0.27

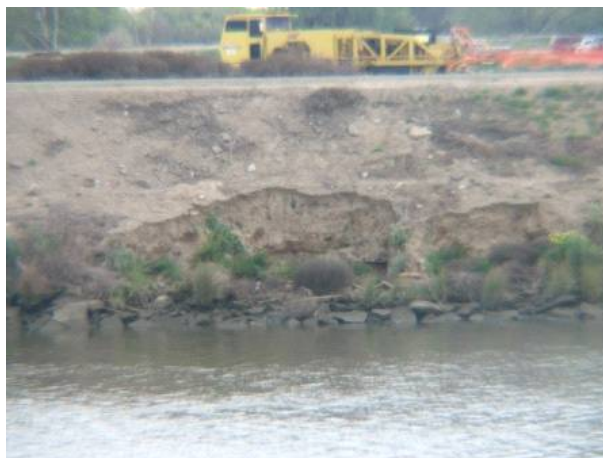
Levee Mile Report Line	9
Start Levee Mile	0.24
End Levee Mile	0.27
Location	Water Side
Category	Earthen Levee
Item	Erosion / Bank Caving

Erosion at LM 0.27

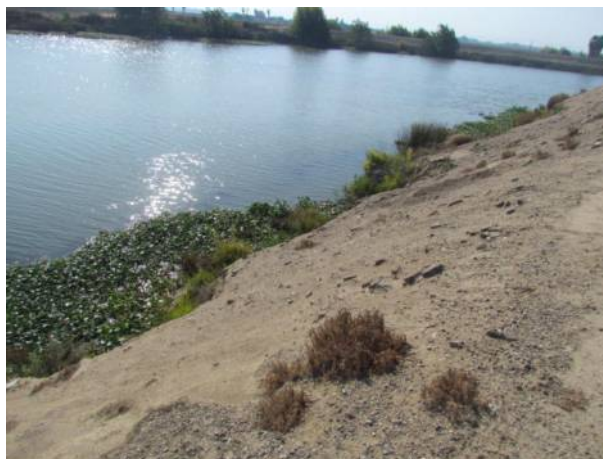
Levee Mile Report Line	10
Start Levee Mile	0.30
End Levee Mile	0.30
Location	Water Side
Category	Earthen Levee
Item	Erosion / Bank Caving

Looking northwest at toe erosion on waterside.

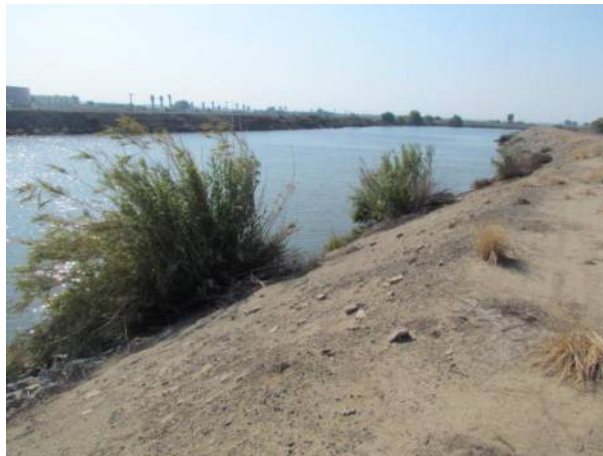
Levee Mile Report Line	11
Start Levee Mile	0.45
End Levee Mile	0.45
Location	Water Side
Category	Earthen Levee
Item	Vegetation

Looking northwest at bamboo on waterside toe.

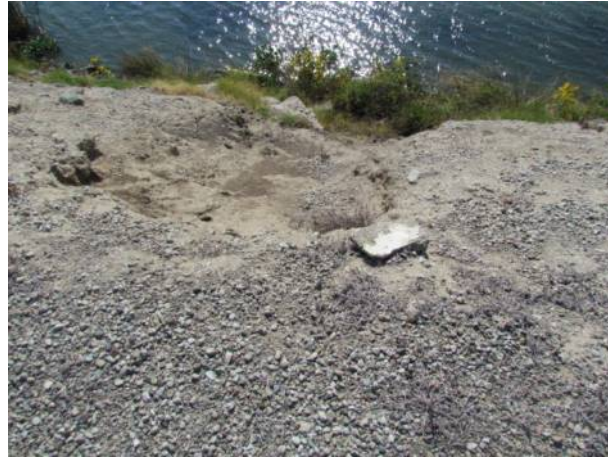
Levee Mile Report Line	12
Start Levee Mile	0.61
End Levee Mile	0.61
Location	Water Side
Category	Earthen Levee
Item	Erosion / Bank Caving

Looking south at erosion on waterside slope.

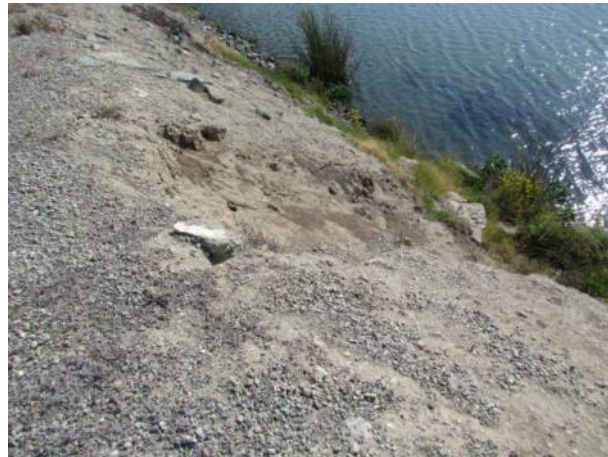
Levee Mile Report Line	12
Start Levee Mile	0.61
End Levee Mile	0.61
Location	Water Side
Category	Earthen Levee
Item	Erosion / Bank Caving

Looking west at erosion on waterside slope.

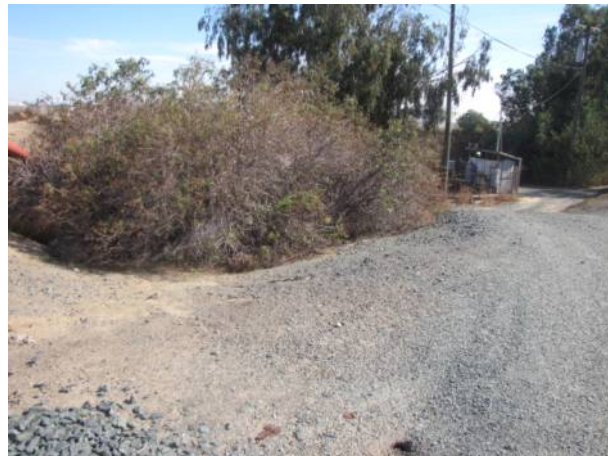
Levee Mile Report Line	13
Start Levee Mile	0.75
End Levee Mile	0.75
Location	Land Side
Category	Earthen Levee
Item	Vegetation

Looking southeast at elderberry on landside slope.

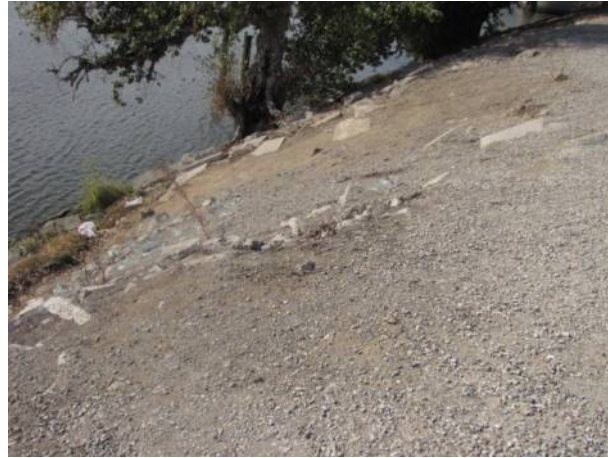
Levee Mile Report Line	19
Start Levee Mile	1.63
End Levee Mile	1.63
Location	Water Side
Category	Earthen Levee
Item	Slope Stability

Looking southwest at minor slope sliding on waterside slope.

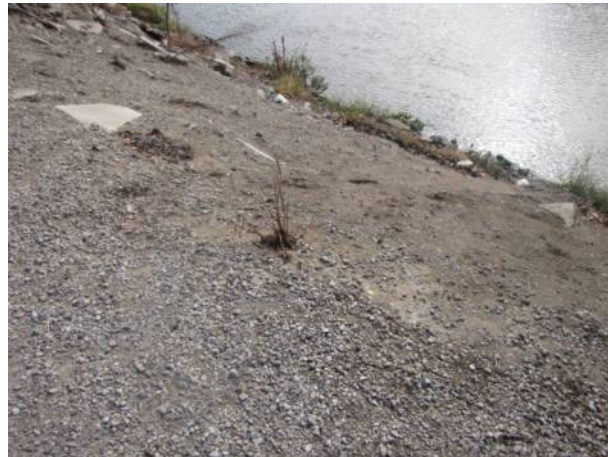
Levee Mile Report Line	19
Start Levee Mile	1.63
End Levee Mile	1.63
Location	Water Side
Category	Earthen Levee
Item	Slope Stability

Looking southeast at minor slope sliding on waterside slope.

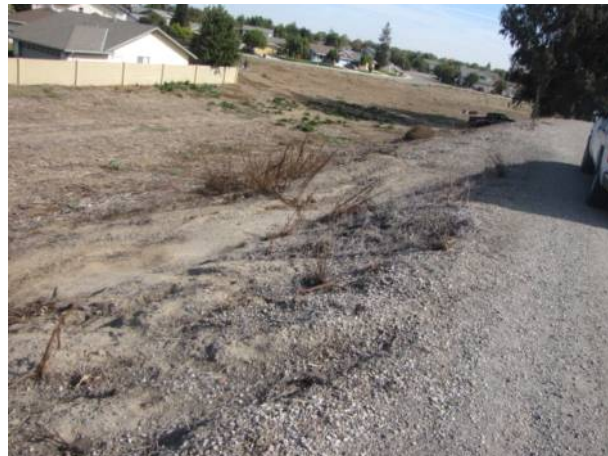
Levee Mile Report Line	20
Start Levee Mile	1.64
End Levee Mile	1.65
Location	Land Side
Category	Earthen Levee
Item	Slope Stability

Looking northeast at minor slope damage on landside slope cause by vehicle traffic.

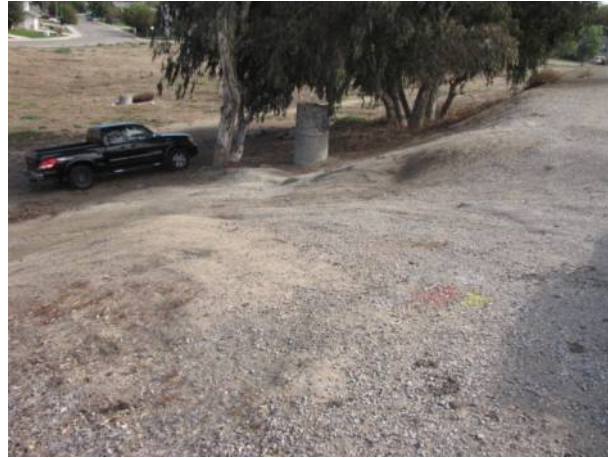
Levee Mile Report Line	20
Start Levee Mile	1.64
End Levee Mile	1.65
Location	Land Side
Category	Earthen Levee
Item	Slope Stability

Looking northeast at slope damage on landside slope cause by vehicle traffic.

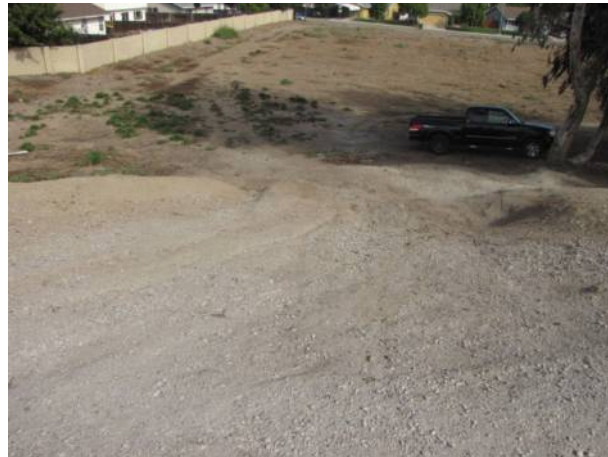
Levee Mile Report Line	20
Start Levee Mile	1.64
End Levee Mile	1.65
Location	Land Side
Category	Earthen Levee
Item	Slope Stability

Looking east at slope damage on landside slope.

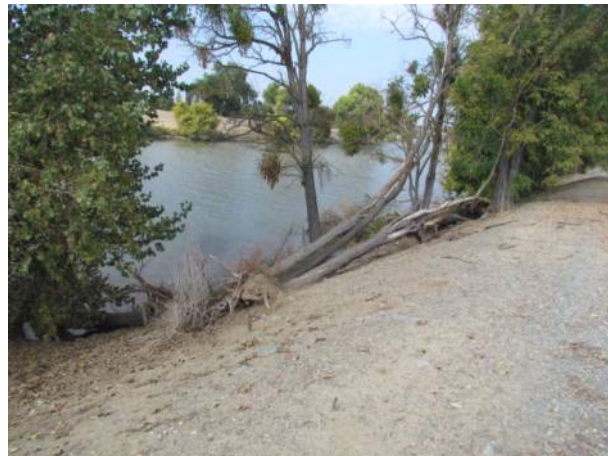
Levee Mile Report Line	22
Start Levee Mile	1.99
End Levee Mile	1.99
Location	Water Side
Category	Earthen Levee
Item	Encroachments

Looking northwest at downed tree on waterside slope.

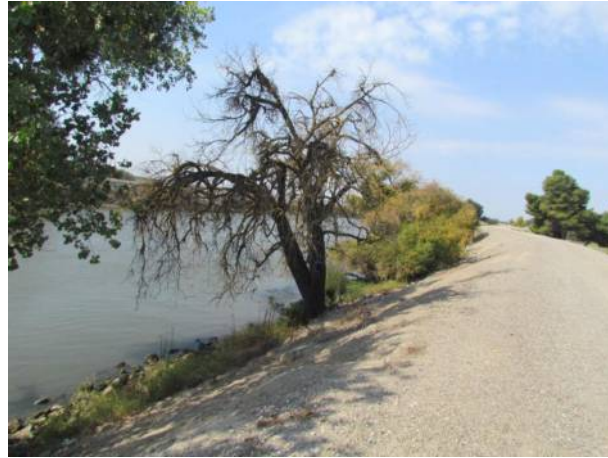
Levee Mile Report Line	23
Start Levee Mile	2.33
End Levee Mile	2.33
Location	Water Side
Category	Earthen Levee
Item	Trim / Thin Trees

Looking northeast at dead tree on waterside toe.

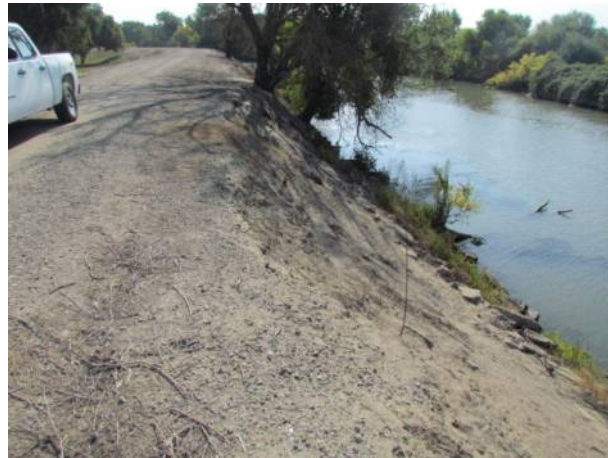
Looking west at waterside slope erosion.

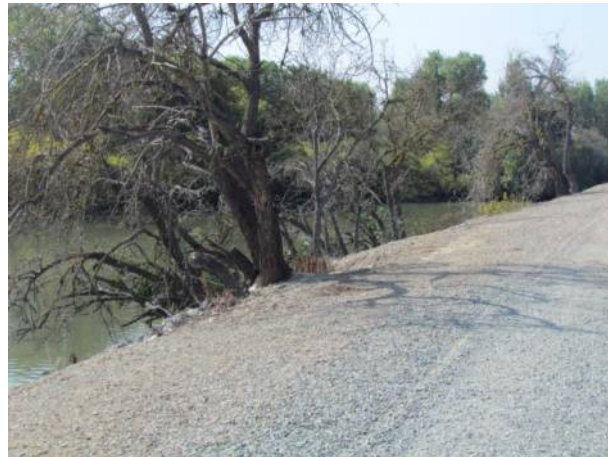
Levee Mile Report Line	3
Start Levee Mile	0.12
End Levee Mile	0.15
Location	Water Side
Category	Earthen Levee
Item	Trim / Thin Trees

Looking northwest at dead trees on waterside slope.

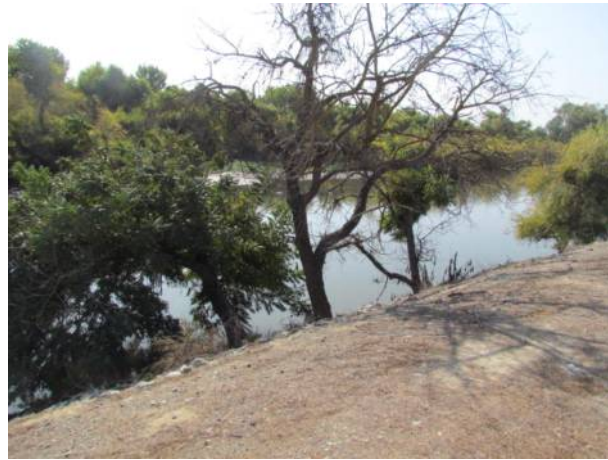
Looking east at dead tree on waterside slope.

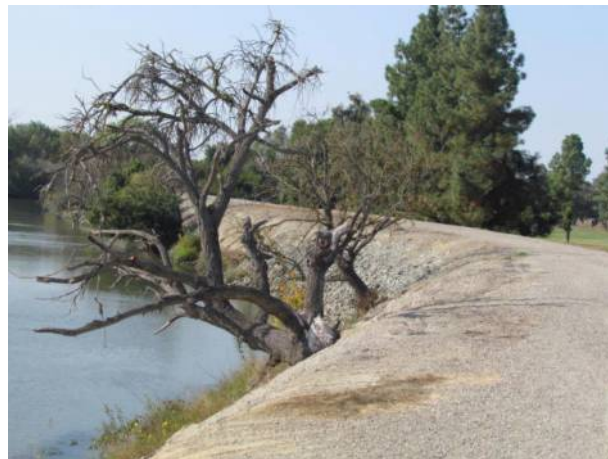
Levee Mile Report Line	7
Start Levee Mile	0.36
End Levee Mile	0.36
Location	Water Side
Category	Earthen Levee
Item	Trim / Thin Trees

Looking northwest at dead tree on waterside slope.

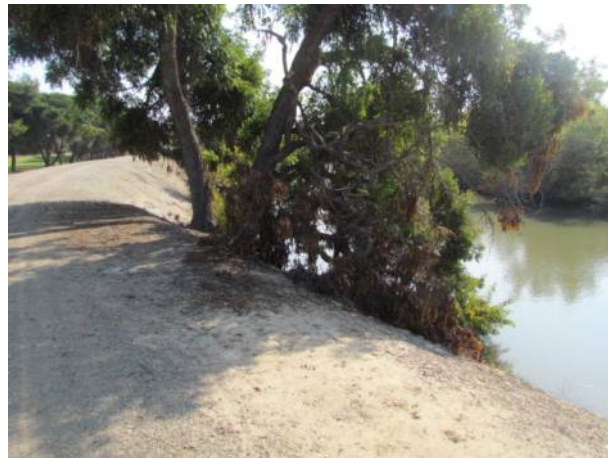
Levee Mile Report Line	10
Start Levee Mile	0.48
End Levee Mile	0.48
Location	Water Side
Category	Earthen Levee
Item	Encroachments

Looking southeast at downed tree limb on waterside slope.

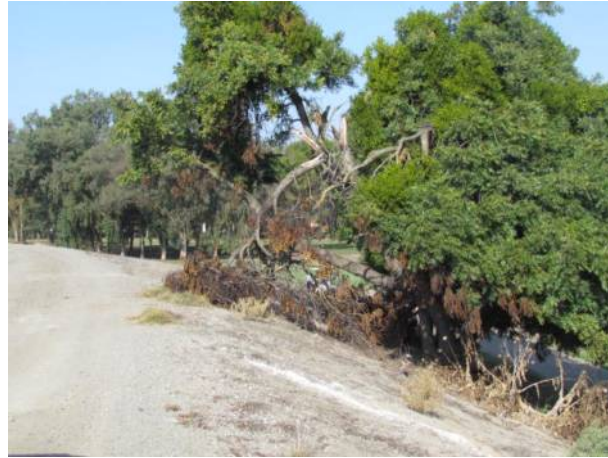
Looking northwest at downed tree limbs on landside slope.

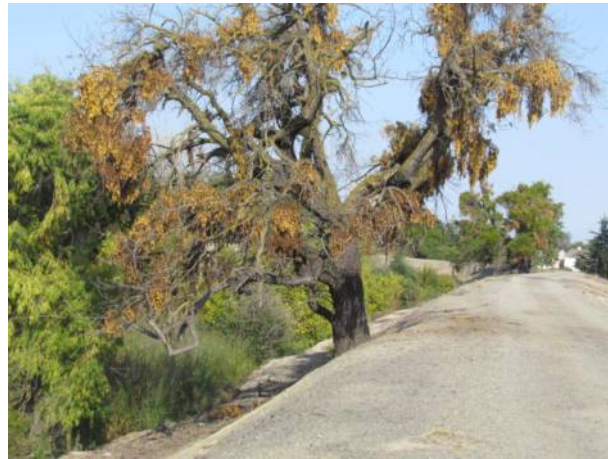
Levee Mile Report Line	15
Start Levee Mile	0.89
End Levee Mile	0.89
Location	Water Side
Category	Earthen Levee
Item	Trim / Thin Trees

Looking northwest at dead tree on waterside slope.

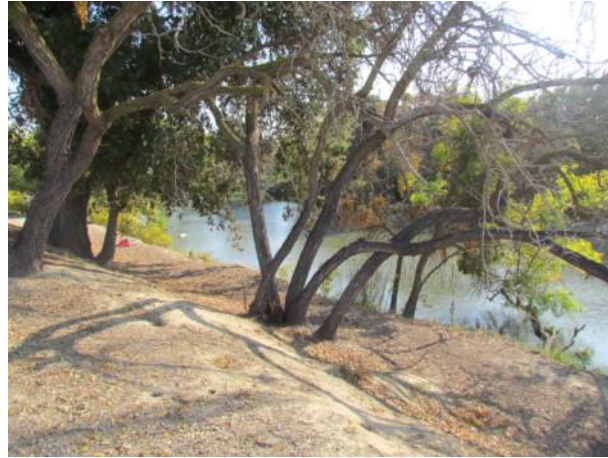
Looking southwest at several dead trees on waterside slope.

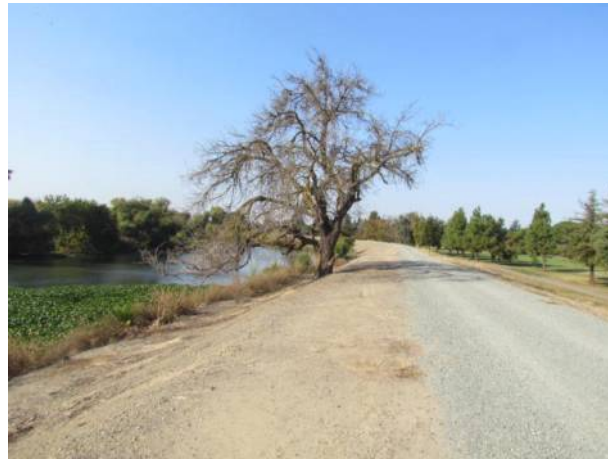
Levee Mile Report Line	22
Start Levee Mile	1.44
End Levee Mile	1.44
Location	Water Side
Category	Earthen Levee
Item	Trim / Thin Trees

Looking east at dead tree on waterside slope.

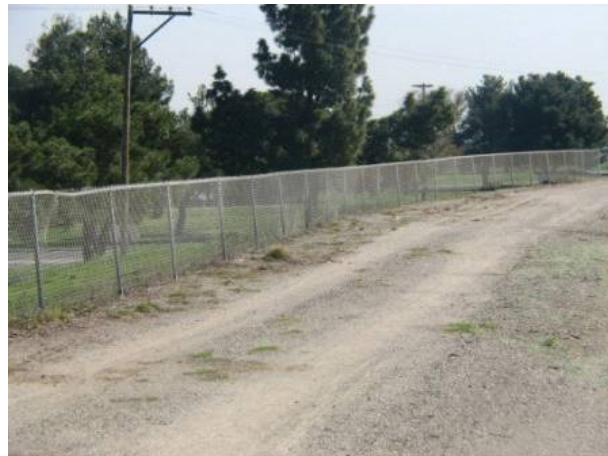
Levee Mile Report Line	23
Start Levee Mile	1.47
End Levee Mile	1.52
Location	Land Side
Category	Earthen Levee
Item	Encroachments

Fence at landside shoulder from LM 1.47 to 1.52

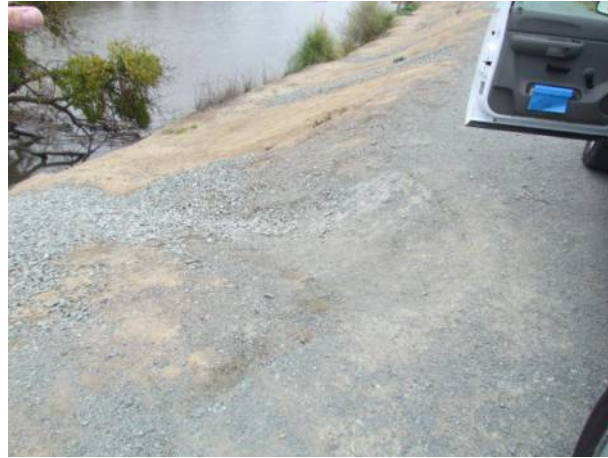
Looking south at one of several foot traffic erosion on waterside slope.

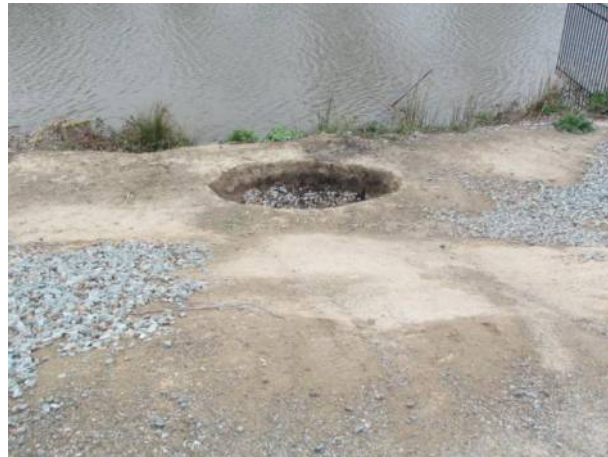
Levee Mile Report Line	25
Start Levee Mile	1.47
End Levee Mile	1.47
Location	Water Side
Category	Earthen Levee
Item	Erosion / Bank Caving

Looking south at possible sink hole on waterside berm.

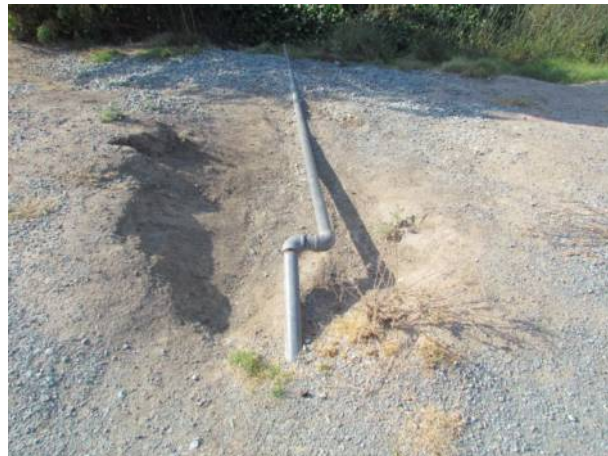
Levee Mile Report Line	27
Start Levee Mile	1.55
End Levee Mile	1.55
Location	Water Side
Category	Earthen Levee
Item	Encroachments

Looking south at 3" pipe on waterside slope.

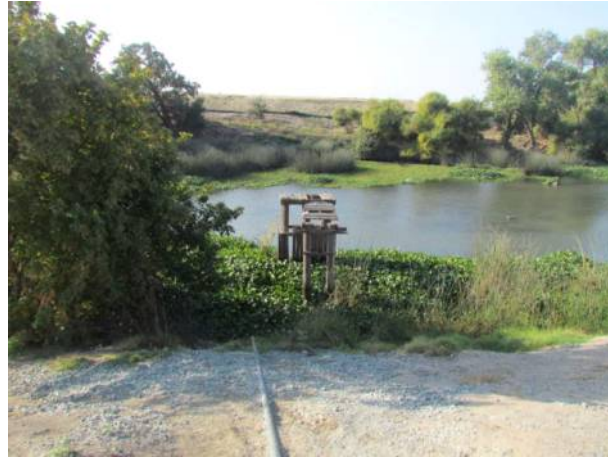
Looking southwest at wooden pump stand in channel.
